Use of a Ground-Coupled Monostatic antenna for Determining Deterioration of Concrete Structures

Doria L. Kutrubes
Radar Solutions International
51 Riverview Avenue, Waltham, MA 02453-3819
radar@world.std.com

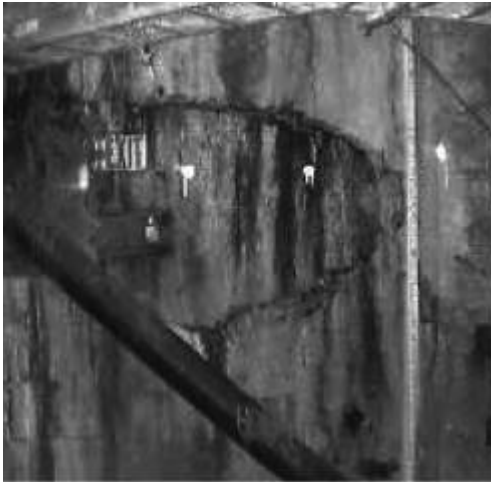
Figure 2: Cracking and staining observed on north wall of AST
